**Flood Control Project Maintenance
Levee Inspections**

Fall 2018 Levee Maintenance Deficiency Summary Report

Sacramento River Basin

**Flood Control Project Maintenance
Levee Inspections****LMA District Cover Sheet****Fall 2018 Levee Inspection Results****Sutter Maintenance Yard Maintenance Area 0013**

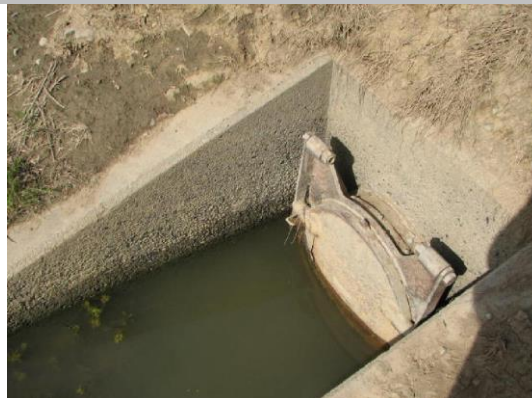
Photo 3 of 3 : UCIP_FA_2018_52212_66842.jpg

Comment Code						
Inspector Comment						
FS_ID:52212 DS_ID:16354 EP_NO: N/A Repair Type: Non-Urgent Crossing Status: Found UCIP Comments: 6/14/2017 LS slide gate stem still bent. WS appeared to be in good condition. Pipe has been selected to be internally cleaned and inspected as part of the DMP project. (DWR Sutter Yard- AFreitag)11/16/2016 Screw gate stem bent but gate is still operational. (DWR Sutter Yard- AFreitag)4/28/2106 Tested positive closure device the bent stem on the slide gate did not seem to affect its functions. Gate operable.7/13/2015 LS screw gate stem is still bent. Gate should still be able to close fully. The rest of the crossing seems to be in good condition.5/21/2014 Same as last inspection.12/2/2013 Same as last inspection.7/15/2013 Slopes have been cleared of vegetation and are in good condition. LS screw gate stem is still bent.4/18/2012 LS slide gate stem is bent and needs to be replaced. Limited inspection on WS and LS slope due to dense vegetation. Need photos of cleared slopes during next inspection. Confirmed flap gate on WS. This crossing was listed in the USACE Periodic Inspection report as Corp's inspect ID#USACE_CESPK_M13D_2011_p_0244 for submerged WS gate. FIELD_STRUCT_DESC: 24-inch corrugated metal drainage pipe through the levee, 11.2 feet below the crown. Flap gate on the waterside (WS) end. Slide gate on the landside (LS) end. Concrete "U" headwall on both ends. [Additional Reference(s): DWR Levee Log, 1993. USACE Sacramento O&M Manual 519, June 1962 (HLM 7.34)] FS Date: 6/19/2017 10:19:12 AM

WS Flap Gate

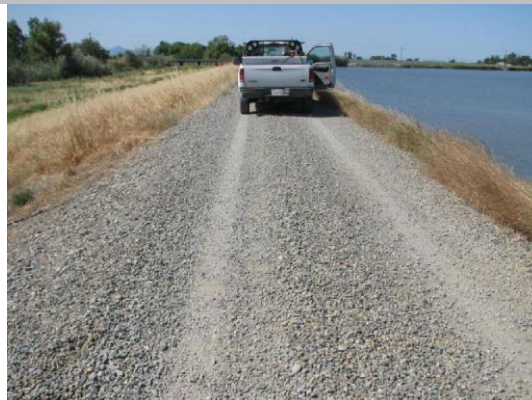
Photo 1 of 3 : UCIP_FA_2018_52213_66853.jpg

Comment Code					
Inspector Comment					
FS_ID:52213 DS_ID:16352 EP_NO: N/A Repair Type: No Action Needed Crossing Status: Found UCIP Comments: 6/14/2017 Crossing appears to be in good condition. Pipe has been selected to be internally cleaned and inspected as part of the DMP project. (DWR Sutter Yard- A Freitag)11/16/2016 Crossing appears to be in good condition. (DWR Sutter Yard- A Freitag)4/28/2016 Crossing appears to be in good condition. 7/13/2015 WS ditch is getting to be heavily vegetated but it is not yet affecting flap gate operation. Vegetation needs to be cleared back some.5/21/2014 Same as last inspection.12/2/2013 Same as last inspection.7/15/2013 Slopes have been cleared of vegetation and are in good condition.4/18/2012 Limited inspection on WS and LS slopes due to dense vegetation. Need photos of cleared WS and LS slopes during next inspection. FIELD_STRUCT_DESC: 24-inch corrugated metal drainage pipe through the levee, 10.2 feet below the crown. Flap gate on the waterside (WS) end. Screw gate on the landside (LS) end. Concrete headwall on both ends. [Additional Reference(s): DWR Levee Log, 1993. USACE Sacramento O&M Manual 519, June 1962 (HLM 7.58)] FS Date: 6/19/2017 10:29:30 AM

View of levee crown at crossing looking D/S.

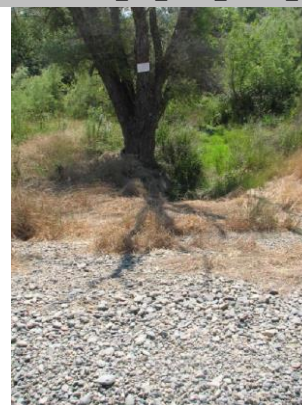
Photo 2 of 3 : UCIP_FA_2018_52213_66851.jpg

WS view of slope and channel.

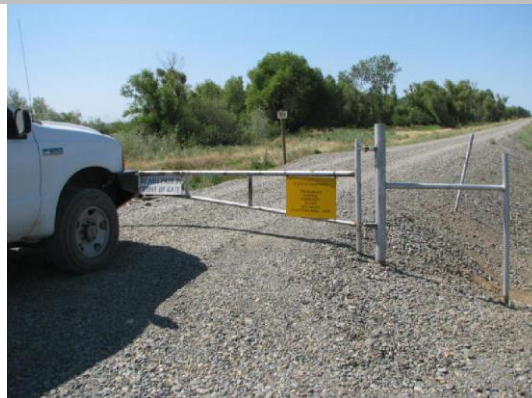
Photo 1 of 3 : UCIP_FA_2018_52217_66867.jpg

Comment Code					
Inspector Comment					
FS_ID:52217 DS_ID:16320 EP_NO: N/A Repair Type: No Action Needed Crossing Status: Found UCIP Comments: 6/14/2017 Debris down inside of WS riser. The rest of the crossing appears to be in good condition. Pipe has been selected to be internally cleaned and inspected as part of the DMP project. (DWR Sutter Yard- A/Freitag)11/16/2016 Crossing appears to be in good condition. (DWR Sutter Yard- A/Freitag)4/28/2016 Crossing appears to be in good condition.7/13/2015 The bottom of the entire pipe has about 8inch of sediment in it. Sediment is preventing the screw gate from fully closing. WS flap gate seems to be in good condition.5/21/2014 Same as last inspection.12/3/2013 Same as last inspection.7/15/2013 Same as last inspection. FIELD_STRUCT_DESC: 48-inch corrugated metal drainage pipe through the levee, 9.9 feet below the crown. Flap gate on the waterside (WS) end. Slide gate in corrugated metal pipe riser on the WS slope. Concrete "U" headwalls on both ends. Spillway grouted for 35 feet. [Additional Reference(s): DWR Levee Log, 1993. USACE Sacramento O&M Manual 519, June 1962 (HLM 7.76)] FS Date: 6/19/2017 12:43:02 PM

Overview of levee crown at crossing (past gate) looking D/S.

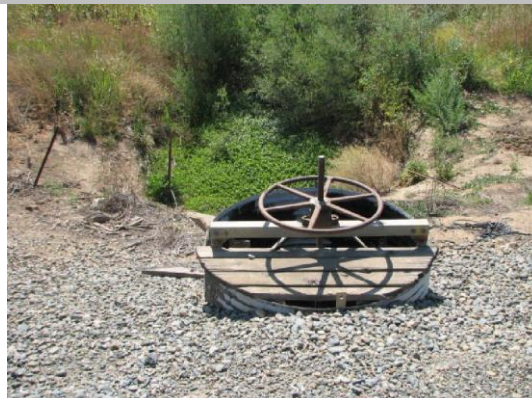
Photo 2 of 3 : UCIP_FA_2018_52217_66865.jpg

View of WS slope, corrugated metal riser with slide gate.

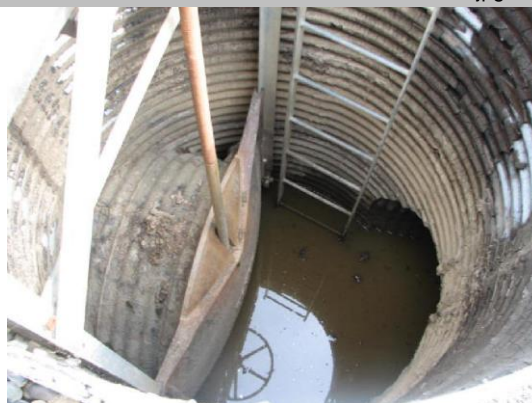
Photo 3 of 3 : UCIP_FA_2018_52217_66863.jpg

Item	DWR UCIP LMA Responsibility		39.493756 °	39.493756 °								
			-121.726570 °	-121.726570 °								
DWR ID	16320											
Comment Code												
Inspector Comment												
FS_ID:52217 DS_ID:16320 EP_NO: N/A Repair Type: No Action Needed Crossing Status: Found UCIP Comments: 6/14/2017 Debris down inside of WS riser. The rest of the crossing appears to be in good condition. Pipe has been selected to be internally cleaned and inspected as part of the DMP project. (DWR Sutter Yard- A Freitag)11/16/2016 Crossing appears to be in good condition. (DWR Sutter Yard- A Freitag)4/28/2016 Crossing appears to be in good condition.7/13/2015 The bottom of the entire pipe has about 8inch of sediment in it. Sediment is preventing the screw gate from fully closing. WS flap gate seems to be in good condition.5/21/2014 Same as last inspection.12/3/2013 Same as last inspection.7/15/2013 Same as last inspection. FIELD_STRUCT_DESC: 48-inch corrugated metal drainage pipe through the levee, 9.9 feet below the crown. Flap gate on the waterside (WS) end. Slide gate in corrugated metal pipe riser on the WS slope. Concrete "U" headwalls on both ends. Spillway grouted for 35 feet. [Additional Reference(s): DWR Levee Log, 1993. USACE Sacramento O&M Manual 519, June 1962 (HLM 7.76)] FS Date: 6/19/2017 12:43:02 PM

WS Slide gate

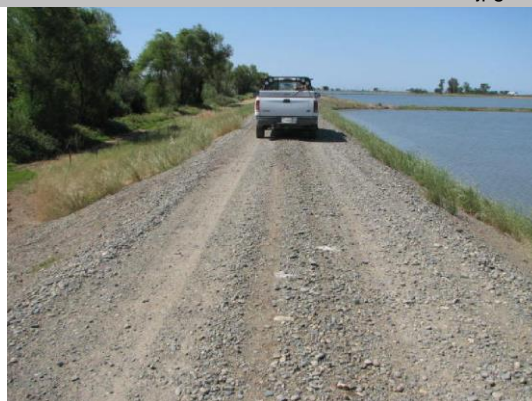
Photo 1 of 3 : UCIP_FA_2018_52218_66872.jpg

Comment Code						
Inspector Comment						
FS_ID:52218 DS_ID:16321 EP_NO: N/A Repair Type: No Action Needed Crossing Status: Found UCIP Comments: 6/14/2017 Crossing appears to be in good condition. Pipe has been selected to be internally cleaned and inspected as part of the DMP project. (DWR Sutter Yard- A Freitag)11/16/2016 Crossing appears to be in good condition. (DWR Sutter Yard- A Freitag)4/28/2016 Crossing appears to be in good condition.7/13/2015 Crossing appears to be in good condition. 5/21/2014 Same as last inspection.12/3/2013 Same as last inspection.7/15/2013 Same as last inspection.4/18/2012 Sediment build up against flashboards. Flashboards are in use on landside of levee. FIELD_STRUCT_DESC: 24-inch corrugated metal drainage pipe through the levee, 8.2 feet below the crown. Flap gate on the waterside (WS) end. Concrete "U" headwalls on both ends. Flashboards should be present on the landside (LS). [Additional Reference(s): DWR Levee Log, 1993. USACE Sacramento O&M Manual 519, June 1962 (HLM 8.12)] FS Date: 6/19/2017 12:45:23 PM

Overview of levee crown at crossing looking D/S.

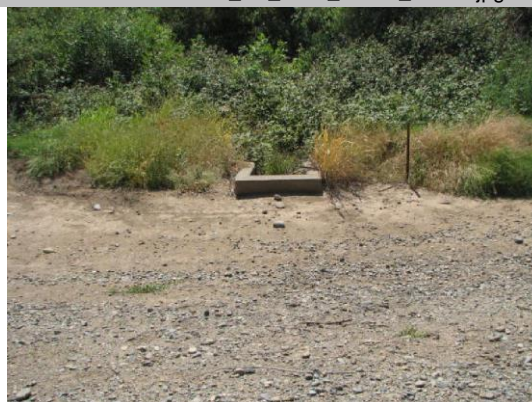
Photo 2 of 3 : UCIP_FA_2018_52218_66873.jpg

View of WS slope and toe.

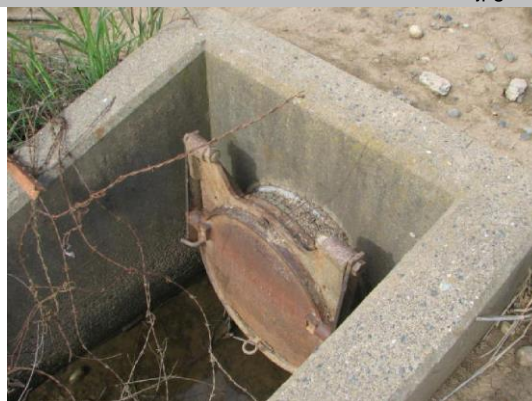
Photo 3 of 3 : UCIP_FA_2018_52218_66869.jpg

WS Flap gate

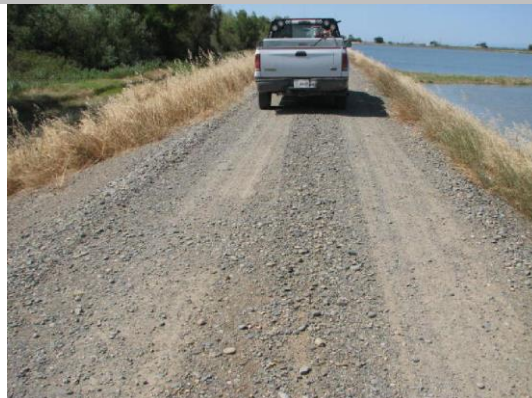
Photo 1 of 3 : UCIP_FA_2018_52219_66876.jpg

FS_ID:52219
DS_ID:16322
EP_NO: N/A
Repair Type: Non-Urgent
Crossing Status: Found
UCIP Comments: 6/14/2017 Both sides of the crossing were buried with sediment- needs to be cleared away. Pipe has been selected to be internally cleaned and inspected as part of the DMP project. (DWR Sutter Yard- A Freitag)11/16/2016 WS flap gate is closed but is blocked from opening by sediment. (DWR Sutter Yard- A Freitag)4/28/2016 Crossing appears to be in good condition.7/13/2015 Minor sediment build up blocking flap gate from opening on WS. Needs to be dug out.5/21/2014 Same as last inspection.12/3/2013 Same as last inspection.7/15/2013 Slopes are cleared of vegetation and are in good condition. WS flapgate is blocked from opening fully by sediment.4/18/2012 Sediment build up on LS. Debris (broken panels) scattered near LS headwall. Limited inspection on WS and LS slope due to dense vegetation. Need photos of cleared WS and LS slopes.

Overview of levee crown at crossing looking D/S.

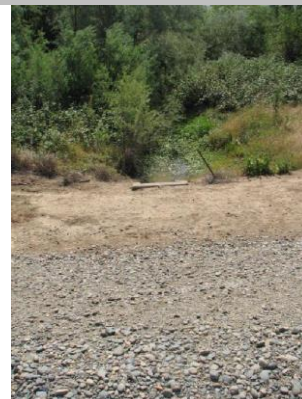
Photo 2 of 3 : UCIP_FA_2018_52219_66874.jpg

View of WS slope and toe.

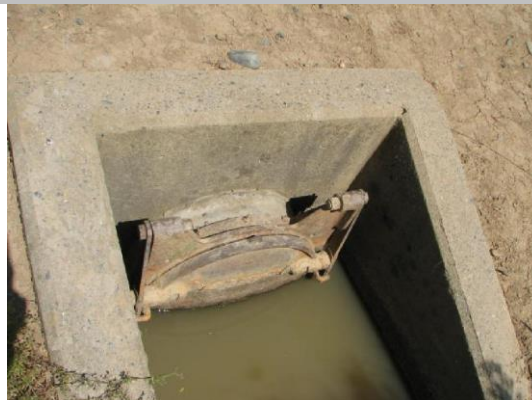
Photo 3 of 3 : UCIP_FA_2018_52219_66877.jpg

Comment Code						
Inspector Comment						
FS_ID:52219 DS_ID:16322 EP_NO: N/A Repair Type: Non-Urgent Crossing Status: Found UCIP Comments: 6/14/2017 Both sides of the crossing were buried with sediment- needs to be cleared away. Pipe has been selected to be internally cleaned and inspected as part of the DMP project. (DWR Sutter Yard- A Freitag)11/16/2016 WS flap gate is closed but is blocked from opening by sediment. (DWR Sutter Yard- A Freitag)4/28/2016 Crossing appears to be in good condition.7/13/2015 Minor sediment build up blocking flap gate from opening on WS. Needs to be dug out.5/21/2014 Same as last inspection.12/3/2013 Same as last inspection.7/15/2013 Slopes are cleared of vegetation and are in good condition. WS flapgate is blocked from opening fully by sediment.4/18/2012 Sediment build up on LS. Debris (broken panels) scattered near LS headwall. Limited inspection on WS and LS slope due to dense vegetation. Need photos of cleared WS and LS slopes. FIELD_STRUCT_DESC: 24-inch corrugated metal drainage pipe through the levee, 9.3 feet below the crown. Flap gate on the waterside (WS) end. Concrete "U" headwalls on both ends. Flashboards should be present on the landside (LS). [Additional Reference(s): DWR Levee Log, 1993. USACE Sacramento O&M Manual 519, June 1962 (HLM 8.40)] FS Date: 6/19/2017 12:47:00 PM

View of WS flap gate and headwall.

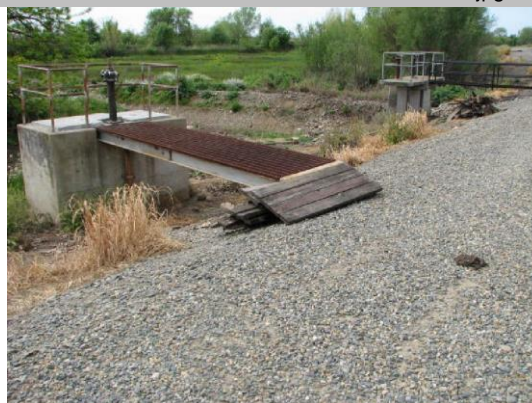
Photo 1 of 3 : UCIP_FA_2018_53310_66881.jpg

Catwalk and screw gate located on WS.

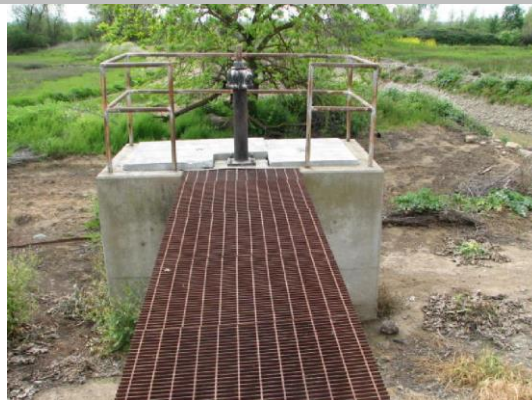
Photo 2 of 3 : UCIP_FA_2018_53310_66884.jpg

Catwalk & gate located on WS. No daylight point on WS.

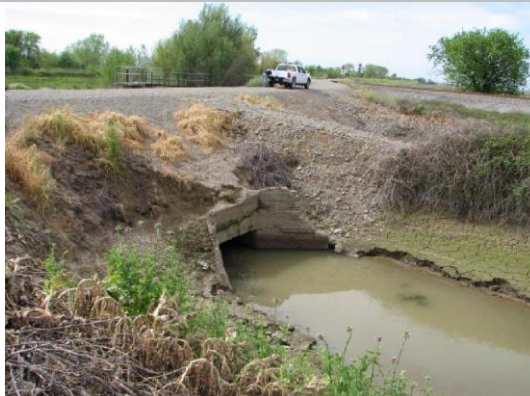
Photo 3 of 3 : UCIP_FA_2018_53310_66882.jpg

Comment Code						
Inspector Comment						
FS_ID:53310 DS_ID:16323 EP_NO: N/A Repair Type: Urgent Crossing Status: Found UCIP Comments: 8/23/2018 Same as last inspection; crossing remains Urgent because LS erosion is still present and poses a levee integrity risk (D. Sanoski - DWR UCIP).6/14/2017 LS underwater but levee erosion is still present- needs to be repaired. Pipe has been selected to be internally cleaned and inspected as part of the DMP project. (DWR Sutter Yard- AFreitag)11/16/2016 LS erosion is still a major problem here. (DWR Sutter Yard- AFreitag)4/28/2016 Erosion still present at the LS headwall. (DWR Sutter Yard - afreitag)7/13/2015 Erosion still present behind the LS headwall. It looks to be getting worse and is starting to affect the levee slope. (DWR Sutter Yard - afreitag)5/21/2014 Same as last inspection. (DWR Sutter Yard - afreitag)12/3/2013 Same as last inspection. (DWR Sutter Yard - afreitag)7/15/2013 Same as last inspection. (DWR Sutter Yard - afreitag)4/18/2012 Concrete headwall is cracked, erosion behind headwall is also present. LS headwall needs to be repaired/replaced. Remove wooden debris from levee shoulder. (DWR UCIP - omagana) FIELD_STRUCT_DESC: [Richvale Irrigation Canal Siphon] 60-inch by 84-inch (5-foot by 7 foot) concrete irrigation conduit through the levee, 18.4 feet below the crown. Distribution box and walkway are located on the waterside (WS). Concrete headwall on the landside (LS). 28-foot reinforced concrete protective slab on top of the conduit in the center of the levee. [Additional Reference(s): DWR Levee Log, 1993. USACE Sacramento O&M Manual 519, June 1962 (HLM 8.95)] FS Date: 8/23/2018 2:32:00 PM

View of LS structure. Erosion present behind headwall.

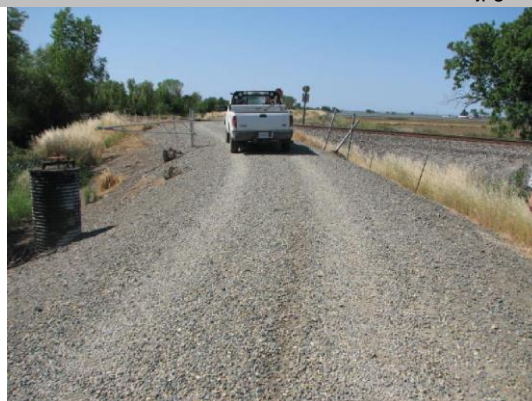
Photo 1 of 3 : UCIP_FA_2018_52223_66895.jpg

Comment Code						
Inspector Comment						
FS_ID:52223 DS_ID:16325 EP_NO: N/A Repair Type: Non-Urgent Crossing Status: Found UCIP Comments: 6/14/2017 Debris drifts built up around the WS slide gates- needs to be cleared away. LS appears to be n good condition. Pipe has been selected to be internally cleaned and inspected as part of the DMP project. (DWR Sutter Yard- AFreitag)11/16/2016 Crossing appears to be in good condition. (DWR Sutter Yard- AFreitag)4/28/2016 Crossing appears to be in good condition.7/13/2015 Crossing appears in good condition. No noticeable issues to report.5/21/2014 Same as last inspection.12/3/2013 Same as last inspection.7/15/2013 LS slope has been sprayed and cleared of vegetation and is in good condition.4/18/2012 Limited inspection on LS slope due to dense vegetation. Need photo of cleared vegetation from slopes and WS headwall. Minor debris scattered on WS slope. FIELD_STRUCT_DESC: 24-inch corrugated metal drainage pipe through the levee, 12.6 feet below the crown. Slide gate in corrugated metal pipe riser on the waterside (WS) slope. Slide gate on the WS end. Concrete "U" headwall on both ends. [Additional Reference(s): DWR Levee Log, 1993. USACE Sacramento O&M Manual 519, June 1962 (HLM 8.98)] FS Date: 6/19/2017 12:59:24 PM

Overview of levee crown at crossing looking D/S.

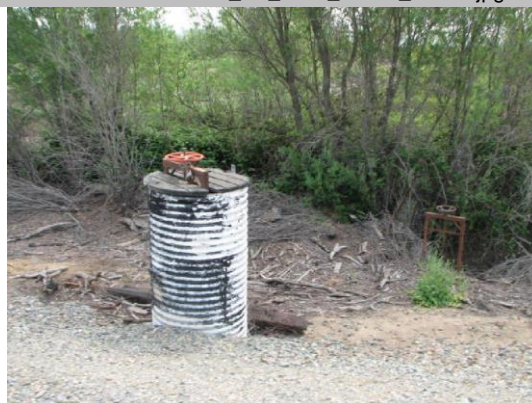
Photo 2 of 3 : UCIP_FA_2018_52223_66897.jpg

View of WS slope with 2 slide gates.

Comment Code						
Inspector Comment						
FS_ID:52223 DS_ID:16325 EP_NO: N/A Repair Type: Non-Urgent Crossing Status: Found UCIP Comments: 6/14/2017 Debris drifts built up around the WS slide gates- needs to be cleared away. LS appears to be n good condition. Pipe has been selected to be internally cleaned and inspected as part of the DMP project. (DWR Sutter Yard- AFreitag)11/16/2016 Crossing appears to be in good condition. (DWR Sutter Yard- AFreitag)4/28/2016 Crossing appears to be in good condition.7/13/2015 Crossing appears in good condition. No noticeable issues to report.5/21/2014 Same as last inspection.12/3/2013 Same as last inspection.7/15/2013 LS slope has been sprayed and cleared of vegetation and is in good condition.4/18/2012 Limited inspection on LS slope due to dense vegetation. Need photo of cleared vegetation from slopes and WS headwall. Minor debris scattered on WS slope. FIELD_STRUCT_DESC: 24-inch corrugated metal drainage pipe through the levee, 12.6 feet below the crown. Slide gate in corrugated metal pipe riser on the waterside (WS) slope. Slide gate on the WS end. Concrete "U" headwall on both ends. [Additional Reference(s): DWR Levee Log, 1993. USACE Sacramento O&M Manual 519, June 1962 (HLM 8.98)] FS Date: 6/19/2017 12:59:24 PM

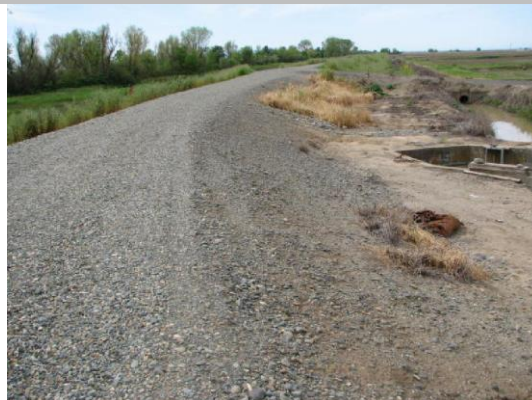
Photo 1 of 3 : UCIP_FA_2018_52225_66908.jpg

Comment Code					
Inspector Comment					
FS_ID:52225 DS_ID:16828 EP_NO: N/A Repair Type: Non-Urgent Crossing Status: Found UCIP Comments: 6/14/2017 Erosion still present on the side of the LS structure- still not affecting levee yet. (DWR Sutter Yard-AFreitag)11/16/2016 Some erosion still present near the LS structure. Does not affect the levee yet. (DWR Sutter Yard-AFreitag)4/28/2016 Erosion happening around the concrete structure on LS. Its not yet affecting the levee but will keep monitoring.7/13/2015 Crossing appears in good condition. No noticeable issues to report.5/21/2014 Same as last inspection.12/3/2013 Same as last inspection.7/15/2013 Same as last inspection.4/18/2012 Crossing is not visible on WS. FIELD_STRUCT_DESC: 72-inch irrigation pipe through the levee located 14.2 feet below the crown. Appurtenances include concrete pipe siphon, screw gate, and distribution box visible on the landside (LS). No appurtenances found on the waterside (WS). [Additional Reference(s): DWR Levee Log, 1993. USACE Sacramento O&M Manual 519, June 1962 (HLM 9.02)] FS Date: 6/19/2017 1:05:30 PM

Overview picture looking south

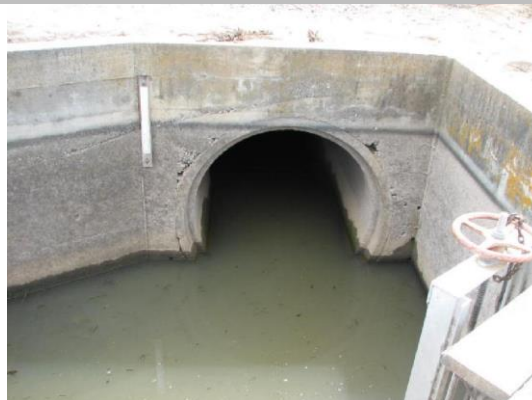
Photo 2 of 3 : UCIP_FA_2018_52225_66907.jpg

Headwall at LS distribution box

Comment Code						
Inspector Comment						
FS_ID:52225 DS_ID:16828 EP_NO: N/A Repair Type: Non-Urgent Crossing Status: Found UCIP Comments: 6/14/2017 Erosion still present on the side of the LS structure- still not affecting levee yet. (DWR Sutter Yard-AFreitag)11/16/2016 Some erosion still present near the LS structure. Does not affect the levee yet. (DWR Sutter Yard-AFreitag)4/28/2016 Erosion happening around the concrete structure on LS. Its not yet affecting the levee but will keep monitoring.7/13/2015 Crossing appears in good condition. No noticeable issues to report.5/21/2014 Same as last inspection.12/3/2013 Same as last inspection.7/15/2013 Same as last inspection.4/18/2012 Crossing is not visible on WS. FIELD_STRUCT_DESC: 72-inch irrigation pipe through the levee located 14.2 feet below the crown. Appurtenances include concrete pipe siphon, screw gate, and distribution box visible on the landside (LS). No appurtenances found on the waterside (WS). [Additional Reference(s): DWR Levee Log, 1993. USACE Sacramento O&M Manual 519, June 1962 (HLM 9.02)] FS Date: 6/19/2017 1:05:30 PM

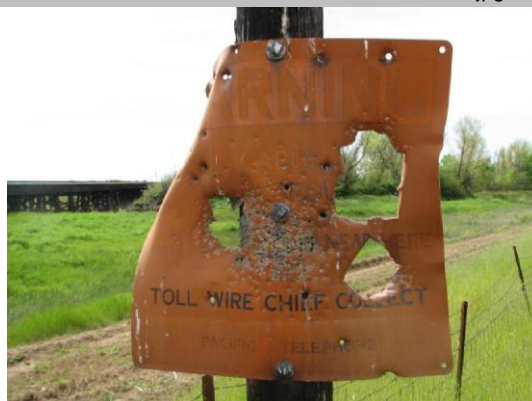
Photo 1 of 1 : UCIP_FA_2018_52226_66909.jpg

Comment Code					
Inspector Comment					
FS_ID:52226 DS_ID:16328 EP_NO: 1234A Repair Type: Non-Urgent Crossing Status: Indicator Found UCIP Comments: 6/14/2017 WS marker missing. (DWR Sutter Yard-AFreitag)11/16/2016 WS marker is knocked over and laying on the ground. (DWR Sutter Yard- AFreitag)4/28/2016 Marker missing on WS.7/13/2015 Crossing appears in good condition. No noticeable issues to report.Need to contact owner to replace marker.7/15/2013 Same as last inspection.12/3/2013 Same as last inspection.5/21/2014 Same as last inspection. FIELD_STRUCT_DESC: Underground telephone cable through the levee at an unknown depth below the crown. (Permit No. 1234, 1234A, 1947 - Pacific Telephone and Telegraph Company [PT&T]) [Additional Reference(s): DWR Levee Log, 1993] FS Date: 6/19/2017 1:08:10 PM

Underground telephone cable marker located on WS.

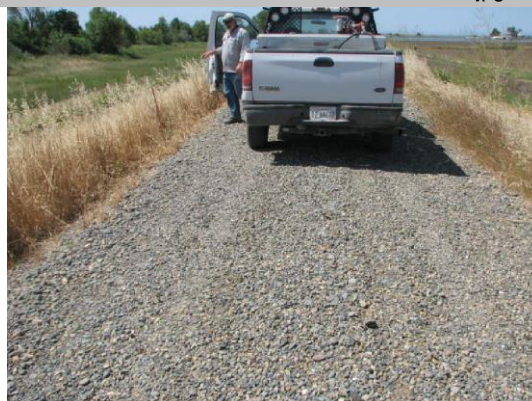
Photo 1 of 3 : UCIP_FA_2018_52227_66910.jpg

Overview of levee crown at crossing looking downstream.

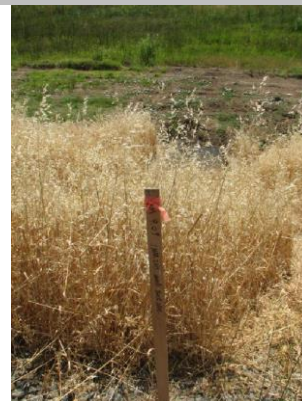
Photo 2 of 3 : UCIP_FA_2018_52227_66911.jpg

View of WS slope and toe.

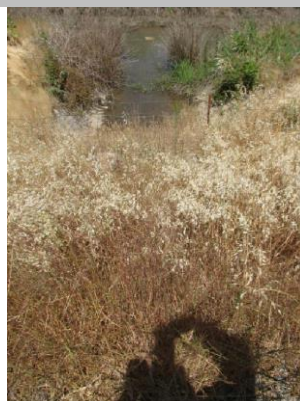
Photo 3 of 3 : UCIP_FA_2018_52227_66912.jpg

View of LS slope and toe.

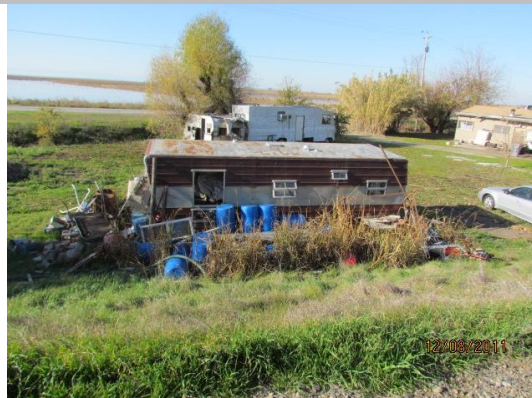
Photo 1 of 1 : FA_2018_MA0013_300_10_20180905_00003.jpg

LM Start	9.73	Rating **	M	Issue No.	10
LM End	9.75	Issue Type +	En	Location *	LS
Category	Earthen Levee			GPS Latitude/Longitude	
				Start	End
Item	Encroachments			39.466732 °	39.466478 °
				-121.744180 °	-121.744338 °
DWR ID	DWR_MA0013_01_f_2013_10				
Comment Code					
MA : Material					
Inspector Comment					
Move the trailer and materials outside the 10 foot easement.

View of a trailer and material along the landside toe.

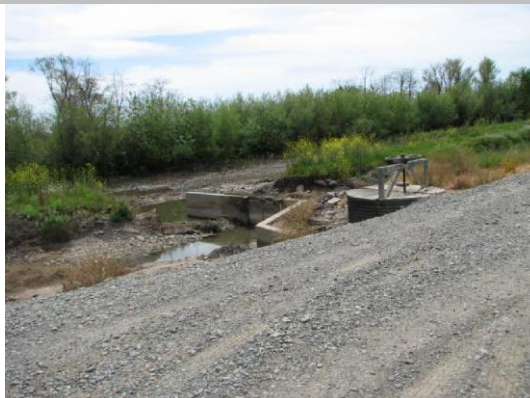
Photo 1 of 3 : UCIP_FA_2018_52232_66926.jpg

View of WS corrugated metal riser and concrete wall.

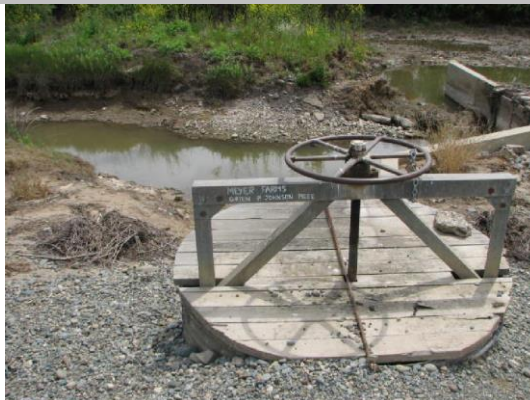
Photo 2 of 3 : UCIP_FA_2018_52232_66925.jpg

Corrugated metal riser with owner information.

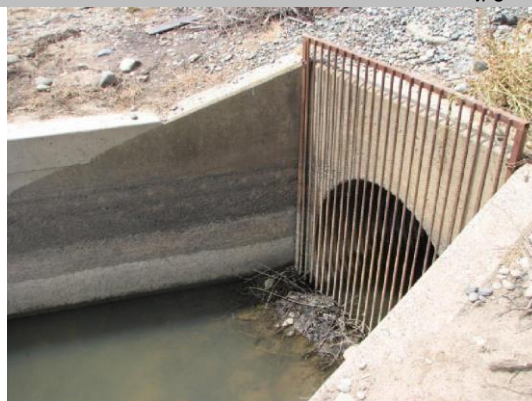
Photo 3 of 3 : UCIP_FA_2018_52232_66928.jpg

Trash rack on WS headwall.

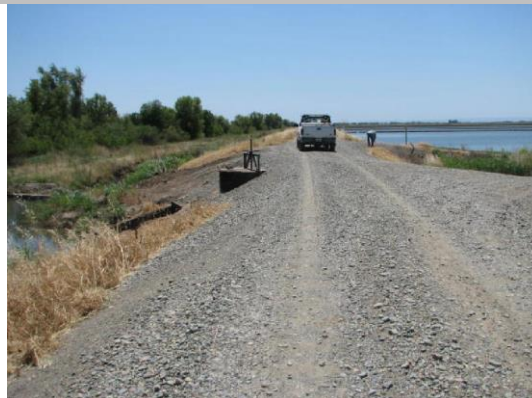
Photo 1 of 3 : UCIP_FA_2018_52233_66934.jpg

Overview of levee crown at crossing looking downstream.

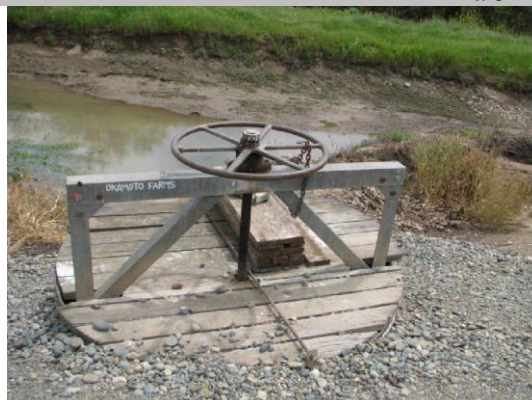
Photo 2 of 3 : UCIP_FA_2018_52233_66932.jpg

WS slide gate with owner information.

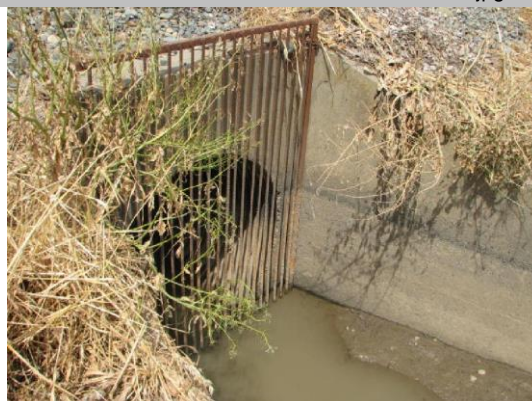
Photo 3 of 3 : UCIP_FA_2018_52233_66930.jpg

Trash rack on WS headwall.

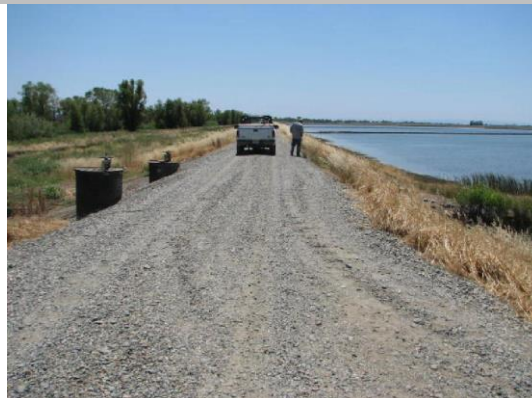
Photo 1 of 3 : UCIP_FA_2018_52234_66940.jpg

FS_ID:52234
DS_ID:16334
EP_NO: N/A
Repair Type: Non-Urgent
Crossing Status: Found
UCIP Comments: 6/15/2017 WS pipe end still unknown- try to locate using GPR/ utility locator. Pipe has been selected to be internally cleaned and inspected as part of the DMP project. (DWR Sutter Yard- A Freitag) 11/17/2016 Cannot locate the WS pipe end. (DWR Sutter Yard- A Freitag) 4/28/2016 Crossing appears to be in good condition but could not locate the WS pipe end. 7/13/2015 New screw gate installed inside the WS standpipe. 5/21/2014 Same as last inspection. 12/3/2013 Same as last inspection. 7/15/2013 Slopes have been cleared of vegetation and are in good condition. Still no sign of WS end of pipe. 4/18/2012 Limited inspection on WS and LS slope due to dense vegetation. WS outlet of pipe not found. Need photos of cleared WS and LS slopes. Determine if WS outlet daylight after WS slope is cleared.
FIELD_STRUCT_DESC: 30-inch corrugated metal drainage pipe through the levee, 11 feet below the crown. Slide gate in corrugated metal pipe riser on the waterside (WS) slope. Concrete "U" headwall on the landside (LS). [Additional Reference(s): DWR Levee Log, 1993. USACE Sacramento O&M Manual 519, June 1962 (HLM 12.38)]

Overview of levee crown at crossing looking downstream.

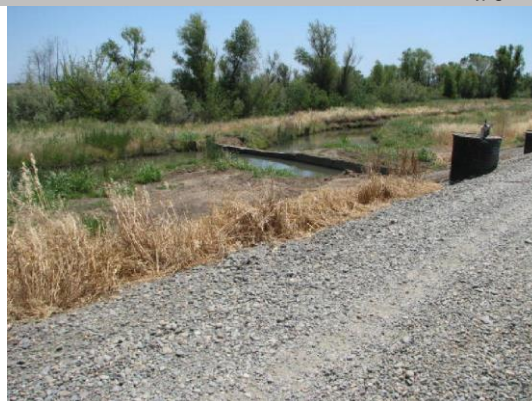
Photo 2 of 3 : UCIP_FA_2018_52234_66936.jpg

View of WS slope and channel.

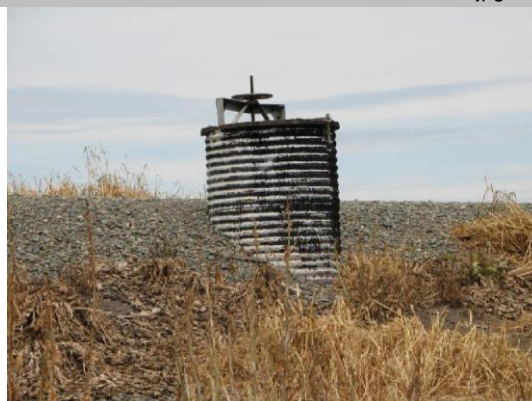
Photo 3 of 3 : UCIP_FA_2018_52234_66939.jpg

Item	DWR UCIP LMA Responsibility			39.435169 °	39.435169 °	
				-121.765290 °	-121.765290 °	
DWR ID	16334					
Comment Code						
Inspector Comment						
FS_ID:52234 DS_ID:16334 EP_NO: N/A Repair Type: Non-Urgent Crossing Status: Found UCIP Comments: 6/15/2017 WS pipe end still unknown- try to locate using GPR/ utility locator. Pipe has been selected to be internally cleaned and inspected as part of the DMP project. (DWR Sutter Yard- A Freitag)11/17/2016 Cannot locate the WS pipe end. (DWR Sutter Yard- A Freitag)4/28/2016 Crossing appears to be in good condition but could not locate the WS pipe end.7/13/2015 New screw gate installed inside the WS standpipe. 5/21/2014 Same as last inspection.12/3/2013 Same as last inspection.7/15/2013 Slopes have been cleared of vegetation and are in good condition. Still no sign of WS end of pipe.4/18/2012 Limited inspection on WS and LS slope due to dense vegetation. WS outlet of pipe not found. Need photos of cleared WS and LS slopes. Determine if WS outlet daylight after WS slope is cleared. FIELD_STRUCT_DESC: 30-inch corrugated metal drainage pipe through the levee, 11 feet below the crown. Slide gate in corrugated metal pipe riser on the waterside (WS) slope. Concrete "U" headwall on the landside (LS). [Additional Reference(s): DWR Levee Log, 1993. USACE Sacramento O&M Manual 519, June 1962 (HLM 12.38)] FS Date: 6/19/2017 1:22:23 PM

Slide gate located on WS slope.

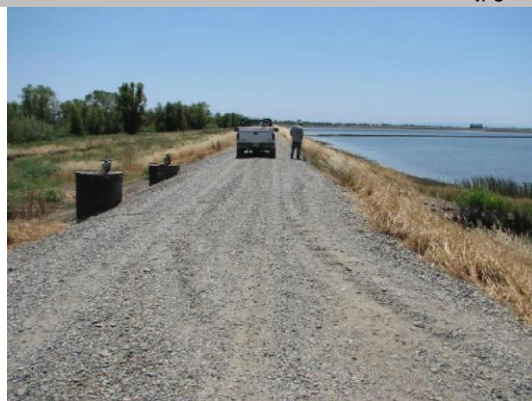
Photo 1 of 3 : UCIP_FA_2018_52235_66949.jpg

Comment Code					
Inspector Comment					
FS_ID:52235 DS_ID:16335 EP_NO: N/A Repair Type: No Action Needed Crossing Status: Found UCIP Comments: 6/15/2017 Crossing appears to be in good condition. Pipe has been selected to be internally cleaned and inspected as part of the DMP project. (DWR Sutter Yard- A Freitag)11/17/2016 Crossing appears to be in good condition. (DWR Sutter Yard- A Freitag)4/28/2016 Crossing appears to be in good condition. 7/13/2015 Crossing appears in good condition. No noticeable issues to report.5/21/2014 Same as last inspection.12/3/2013 Same as last inspection.7/15/2013 LS slope has been cleared of vegetation and is in good condition.4/18/2012 Limited inspection on LS slope due to dry vegetation. Need photos of cleared LS slope. FIELD_STRUCT_DESC: 36-inch corrugated metal drainage pipe through the levee, 9.8 feet below the crown. Slide gate in corrugated metal pipe riser on the waterside (WS) slope. Concrete "U" headwall on the landside (LS). This crossing is used as an irrigation turnout bar code plate located on the WS slide gate (identified as 144). [Additional Reference(s): DWR Levee Log, 1993. USACE Sacramento O&M Manual 519, June 1962 (HLM 12.38)] FS Date: 6/19/2017 1:26:05 PM

Overview of levee crown at crossing looking downstream.

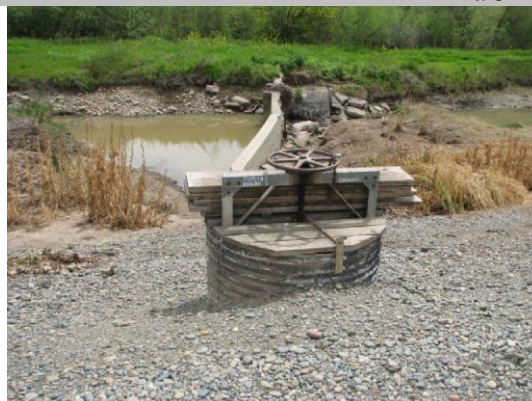
Photo 2 of 3 : UCIP_FA_2018_52235_66947.jpg

View from levee crown of WS slope and channel.

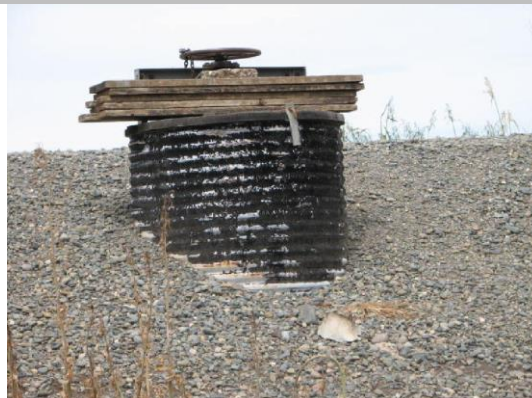
Photo 3 of 3 : UCIP_FA_2018_52235_66948.jpg

Water side screw gate located near crown hinge

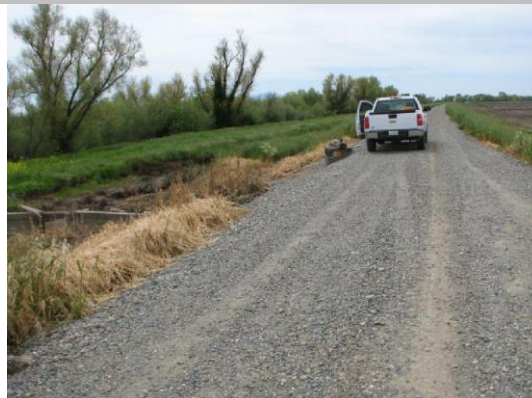
Photo 1 of 3 : UCIP_FA_2018_52236_66952.jpg

Comment Code					
Inspector Comment					
FS_ID:52236 DS_ID:16336 EP_NO: N/A Repair Type: Non-Urgent Crossing Status: Found UCIP Comments: 6/15/2017 Slide gate still missing from inside of WS standpipe. Pipe has been selected to be internally cleaned and inspected as part of the DMP project. (DWR Sutter Yard- AFreitag)11/17/2016 Slide gate still missing from inside the WS standpipe. (DWR Sutter Yard- AFreitag)4/28/2016 Slide gate was removed from inside the WS standpipe.7/13/2015 New screw gate installed on the WS pipe end in the irrigation ditch.5/21/2014 Same as last inspection.12/3/2013 Same as last inspection.7/15/2013 Same as last inspection.4/18/2012 Irrigation turnout. Not in use during April 2012 Inspection. During the follow up May 2012 Inspection structure was being used as irrigation turnout, reason for barcode tags. FIELD_STRUCT_DESC: 30-inch corrugated metal drainage pipe through the levee, 10.7 feet below the crown. Slide gate in corrugated metal pipe (CMP) riser on the waterside (WS) slope. Concrete "U" headwalls on both ends. This crossing is used as an irrigation turnout bar code plate located on the WS slide gate (identified as 141 and 142). [Additional Reference(s): DWR Levee Log, 1993. USACE Sacramento O&M Manual 519, June 1962 (HLM 12.94)] FS Date: 6/19/2017 1:28:43 PM

Overview picture looking south on right bank of Cherokee Canal.

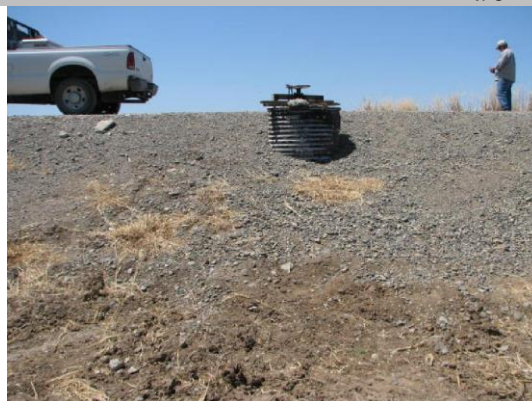
Photo 2 of 3 : UCIP_FA_2018_52236_66959.jpg

View of WS slope.

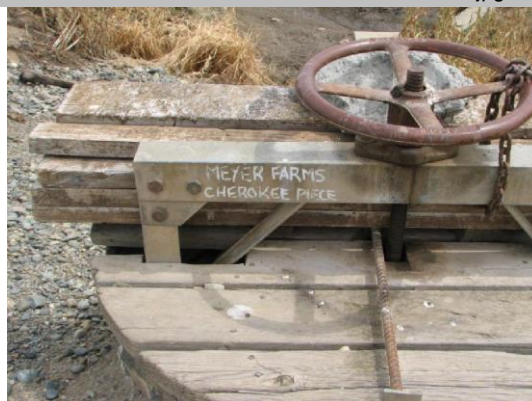
Photo 3 of 3 : UCIP_FA_2018_52236_66951.jpg

Item	DWR UCIP LMA Responsibility			39.428070 °	39.428070 °	
				-121.770080 °	-121.770080 °	
DWR ID	16336					
Comment Code						
Inspector Comment						
FS_ID:52236 DS_ID:16336 EP_NO: N/A Repair Type: Non-Urgent Crossing Status: Found UCIP Comments: 6/15/2017 Slide gate still missing from inside of WS standpipe. Pipe has been selected to be internally cleaned and inspected as part of the DMP project. (DWR Sutter Yard- AFreitag)11/17/2016 Slide gate still missing from inside the WS standpipe. (DWR Sutter Yard- AFreitag)4/28/2016 Slide gate was removed from inside the WS standpipe.7/13/2015 New screw gate installed on the WS pipe end in the irrigation ditch.5/21/2014 Same as last inspection.12/3/2013 Same as last inspection.7/15/2013 Same as last inspection.4/18/2012 Irrigation turnout. Not in use during April 2012 Inspection. During the follow up May 2012 Inspection structure was being used as irrigation turnout, reason for barcode tags. FIELD_STRUCT_DESC: 30-inch corrugated metal drainage pipe through the levee, 10.7 feet below the crown. Slide gate in corrugated metal pipe (CMP) riser on the waterside (WS) slope. Concrete "U" headwalls on both ends. This crossing is used as an irrigation turnout bar code plate located on the WS slide gate (identified as 141 and 142). [Additional Reference(s): DWR Levee Log, 1993. USACE Sacramento O&M Manual 519, June 1962 (HLM 12.94)] FS Date: 6/19/2017 1:28:43 PM

Slide gate located on WS slope. Owner information marked on gate.

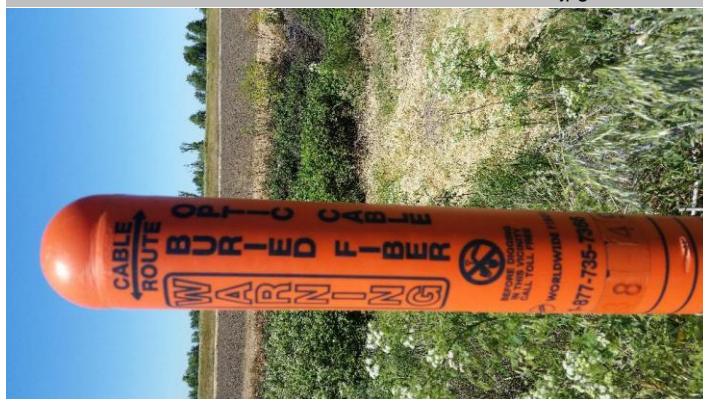
Photo 1 of 2 : UCIP_FA_2018_52237_75014.jpg

FS_ID:52237
DS_ID:16461
EP_NO: 17030
Repair Type: Non-Urgent
Crossing Status: Indicator Found
UCIP Comments: 6/15/2017 No markers present near this levee unit. (DWR Sutter Yard- A Freitag)11/17/2016 Markers missing near the levee. Only marker present is located on the East side of the Unit2 levee. (DWR Sutter Yard- A Freitag)4/28/2016 Lines lines are suspected to be located on the upstream side of the roadway bridge and not the downstream side like the coordinates in this report show. Will need to take new coordinate readings. Markers are missing near levees.7/13/2015 Unable to locate.5/21/2014 Same as last inspection.12/3/2013 Unable to locate.7/15/2013 Same as last inspection. Unable to locate any markers.4/18/2012 Attempt to locate this crossing during next inspection when tall grass is cleared from slopes-look for utility markers.
FIELD_STRUCT_DESC: 8-inch high density polyethylene (HDPE) communication conduit, contains three 2-inch and three 1.5-inch fiber optic cables, backfilled with bentonite on the ends of the bore casing through the levee at an unknown depth below the crown. Conduit is bored across and under Cherokee Canal and its levees. Permit records indicates the conduit is at least 5 feet below the bottom of the low flow of the channel. Owner is listed in the permit as Pacific Fiber Link LLC but permit Inspection sheets list Worldwide Fiber. (Permit No. 17030, 2000 - Worldwide Fiber)

Marker located along side of road about 200 yds east of levees

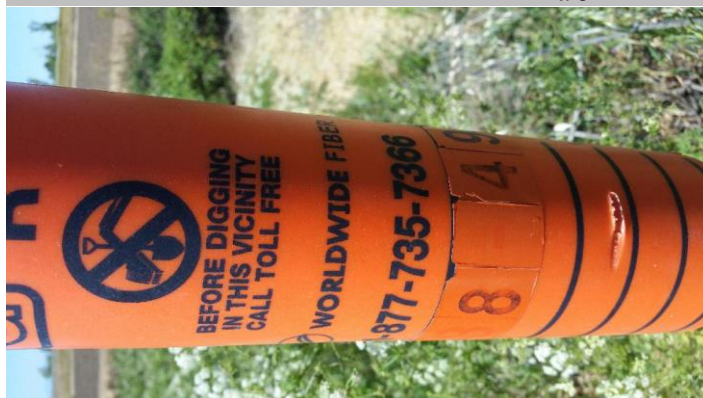
Photo 2 of 2 : UCIP_FA_2018_52237_75015.jpg

Crossing owner contact info

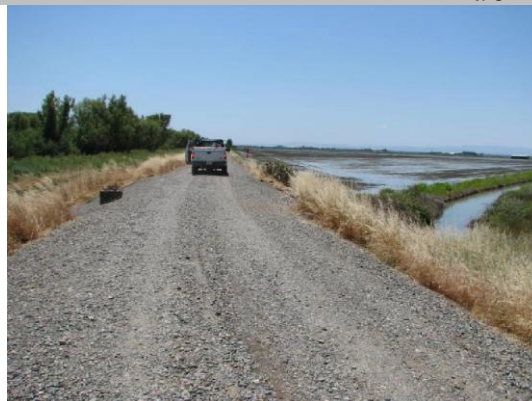
Photo 1 of 3 : UCIP_FA_2018_52238_66966.jpg

Comment Code					
Inspector Comment					
FS_ID:52238 DS_ID:16337 EP_NO: N/A Repair Type: No Action Needed Crossing Status: Found UCIP Comments: 6/15/2017 Crossing appears to be in good condition. Pipe has been selected to be internally cleaned and inspected as part of the DMP project. (DWR Sutter Yard- A Freitag)11/17/2016 Ws pipe end was submerged but crossing appears to be in good condition. (DWR Sutter Yard- A Freitag)5/03/2016 Crossing appears to be in good condition.7/13/2015 New screwgate installed inside of WS standpipe.5/21/2014 Same as last inspection.12/3/2013 Same as last inspection.7/15/2013 Same as last inspection. FIELD_STRUCT_DESC: 24-inch corrugated metal drainage pipe through the levee, 11.1 feet below the crown. Slide gate in corrugated metal pipe (CMP) riser on the waterside (WS) slope. Concrete "U" headwalls on both ends. [Additional Reference(s): DWR Levee Log, 1993. USACE Sacramento O&M Manual 519, June 1962 (HLM 13.53)] FS Date: 6/19/2017 1:33:59 PM

Overview of levee crown at crossing looking downstream.

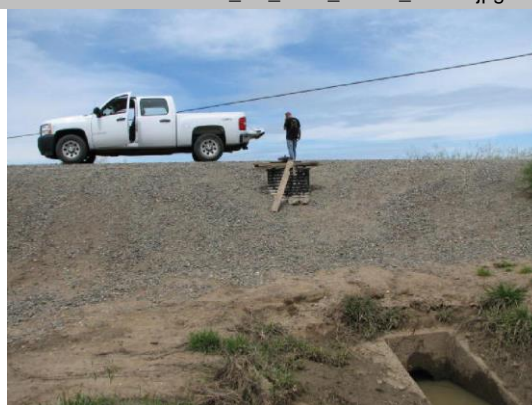
Photo 2 of 3 : UCIP_FA_2018_52238_66963.jpg

View of WS slope.

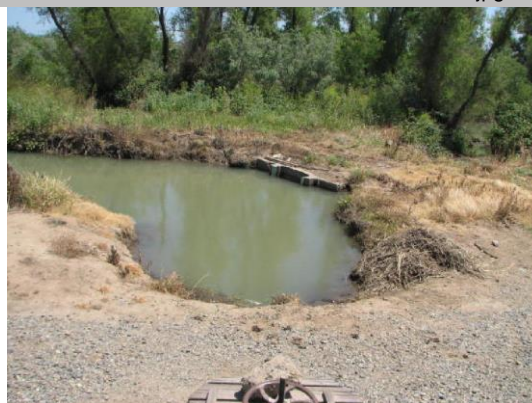
Photo 3 of 3 : UCIP_FA_2018_52238_66967.jpg

View of WS slope and channel.

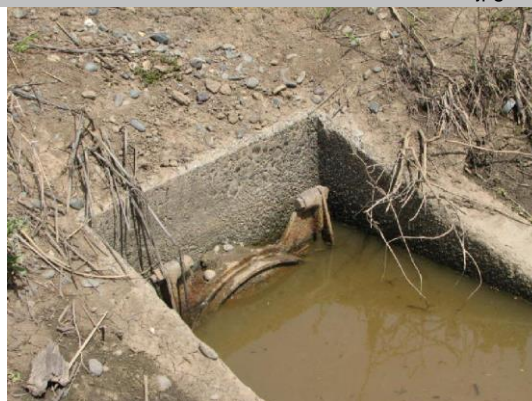
Photo 1 of 3 : UCIP_FA_2018_53315_66970.jpg

UCIP Comments: 8/23/2018 WS flapgate has been replaced. LS outlet still has a lot of vegetation, but overall levee integrity looks good at time of this inspection. Downgrading to Non-Urgent from Urgent due to fixed flapgate and current levee condition (D. Sanoski - DWR UCIP).

6/15/2017 Not abandoned- WS flapgate was dug out and opened draining water from the LS ditch. WS flapgate is heavily corroded and has a broken hinge- needs to be replaced. LS is still very overgrown and needs to be cleared. Pipe has been selected to be internally cleaned and inspected as part of the DMP project. (DWR Sutter Yard- A Freitag) 11/17/2016 Appears abandoned. WS flap gate completely silted over and LS screw gate is completely overgrown by a tree and is not accessible for inspection. (DWR Sutter Yard- A Freitag) 5/3/2016 Crossing appears to be abandoned. WS flap gate was completely silted over and LS slide gate is very overgrown by a tree. 7/13/2015 WS flap gate is blocked from opening by sediment and vegetation. Needs to be cleared away. LS opening is being overgrown by a tree and needs to be cutback. 5/22/2014 Same as last inspection. 12/3/2013 Same as last inspection. 7/15/2013 Same as last inspection. 4/18/2012 Tree has fallen at LS inlet and damaged slide gate. The tree needs to be removed and screw gate repaired. Limited inspection on LS due to fallen tree.

WS headwall and flap gate.

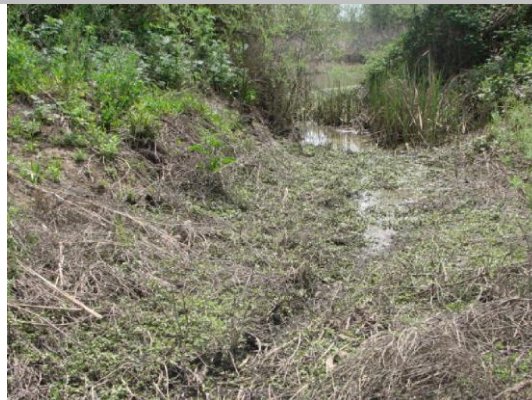
Photo 2 of 3 : UCIP_FA_2018_53315_66971.jpg

View of channel at crossing.

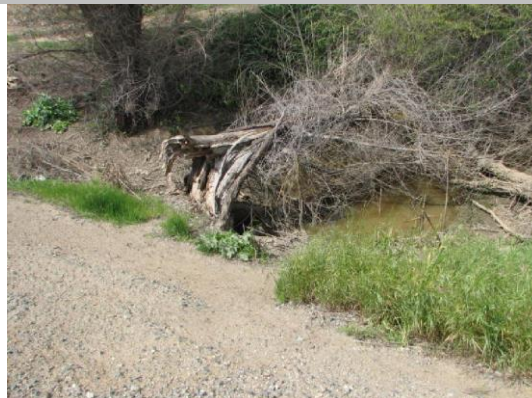
Photo 3 of 3 : UCIP_FA_2018_53315_66969.jpg

Tree fallen at LS headwall.

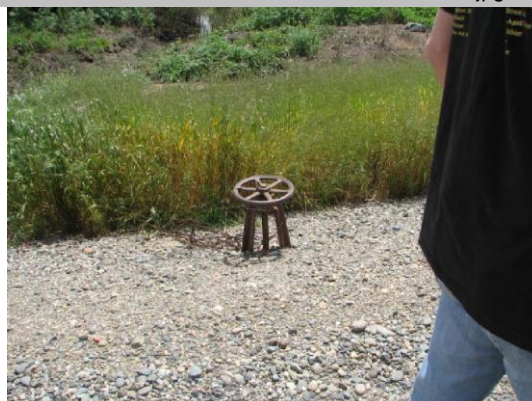
Photo 1 of 2 : UCIP_FA_2018_52240_66972.jpg

Comment Code					
Inspector Comment					
FS_ID:52240 DS_ID:16339 EP_NO: N/A Repair Type: Non-Urgent Crossing Status: Found UCIP Comments: 6/15/2017 Abandoned- still only the structure on the WS shoulder found. (DWR Sutter Yard- A Freitag)11/17/2016 Abandoned. (DWR Sutter Yard- A Freitag)5/03/2016 ABANDONED CROSSING7/13/2015 Abandoned crossing. Slide gate is buried on the WS.5/22/2014 Same as last inspection.12/3/2013 Same as last inspection.7/15/2013 Same as last inspection.4/18/2012 Non-functional crossing-buried slide gate on WS. Limited inspeciton on WS and LS slope/toe due to dense vegetation. Need photo of cleared WS & LS slopes or toe.This crossing is listed in the USACE periodic inspection report as Corp's Inspection ID# USACE_CESPK_M13D_2011_p_0352 for abandoned gate on WS slope. FIELD_STRUCT_DESC: *ABANDONED* 12-inch steel drainage pipe through the levee, 3 feet below the crown. Gate valve on the waterside (WS) slope. 0.25-inch steel plate welded on both ends. [Additional Reference(s): DWR Levee Log, 1993. USACE Sacramento O&M Manual 519, June 1962 (HLM 13.97)] FS Date: 6/19/2017 1:53:35 PM

Buried slide gate on the WS slope.

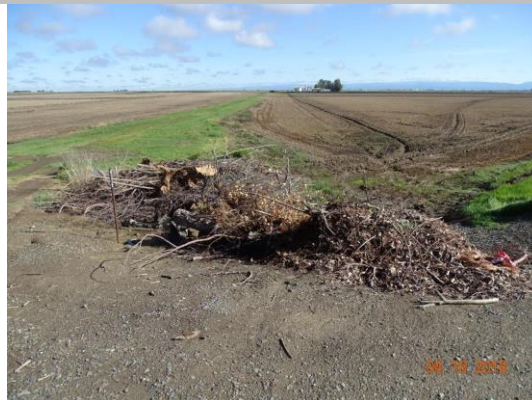
Photo 1 of 1 : FA_2018_MA0013_300_59_20180905_00010.jpg

LM Start	14.22	Rating **	M	Issue No.	59
LM End	14.22	Issue Type +	En	Location *	LS
Category	Earthen Levee			GPS Latitude/Longitude	
				Start	End
Item	Encroachments			39.412726 °	39.412726 °
				-121.788658 °	-121.788658 °
DWR ID	DWR_MA0013_01_f_2016_59				
Comment Code					
DE : Debris					
Inspector Comment					
Remove the debris from the landside slope.

View of the debris along the landside slope.

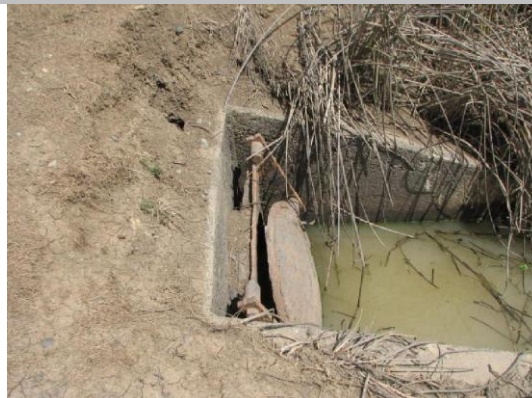
Photo 1 of 3 : UCIP_FA_2018_53317_66976.jpg

UCIP Comments: 8/23/2018 WS pipe unable to be inspected due to heavy vegetation at inlet, so assume same as last inspection. Noticed a long crack a couple feet above WS headwall that could be of concern; possible future slough if soil gets saturated during next high water event and could be a sign of internal pipe degradation. LS outlet and slope looked good. Urgent due to long crack, obstructed inspection view of WS inlet, and 2016 photos of holes in pipe (D. Sanoski - DWR UCIP).6/15/2017 WS pipe end still showing heavy signs of corrosion and deterioration with visible holes between the concrete headwall and flap gate flange. Pipe was almost 100% full of water so could not visually inspect inside of the pipe to see if theres any damage inside of the levee segment. Pipe has been selected to be internally cleaned and inspected as part of the DMP project. (DWR Sutter Yard - AFreitag)11/17/2016 Top of pipe on WS still showing heavy signs of corrosion with visible holes between the flapgate flange and the concrete headwall. The pipe was mostly underwater so could not internally inspect it for more damage or corrosion. (DWR Sutter Yard - AFreitag)5/03/2016 Top of the pipe on the WS has holes in it between the flapgate flange and headwall. Crossing is showing signs of rust and deterioration but it was mostly underwater so could not inspect the inside of the pipe. (DWR Sutter Yard - afreitag)7/13/2015 Both sides of crossing were underwater at the time of inspection. (DWR Sutter Yard - afreitag)5/22/2014 Same as last inspection. (DWR Sutter Yard - afreitag)12/3/2013 Same as last inspection. (DWR Sutter Yard - afreitag)7/15/2013 Slopes have been cleared of vegetation and are in good condition. WS flapgate is still lodged open. (DWR Sutter Yard - afreitag)4/18/2012 Limited inspection on LS slope due to dense vegetation. Need photos of cleared WS & LS slopes. The flap gate is lodged open. (DWR UCIP - omagana)

Headwall and flapgate located on water side of levee

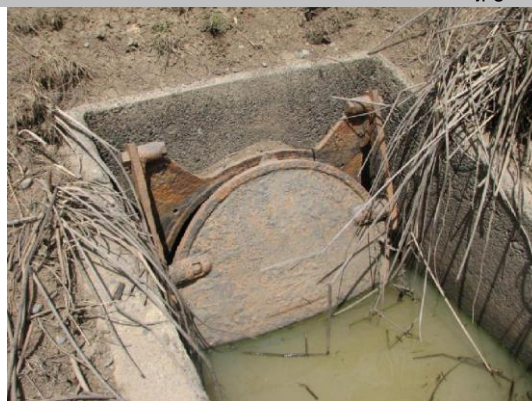
Photo 2 of 3 : UCIP_FA_2018_53317_66974.jpg

UCIP Comments: 8/23/2018 WS pipe unable to be inspected due to heavy vegetation at inlet, so assume same as last inspection. Noticed a long crack a couple feet above WS headwall that could be of concern; possible future slough if soil gets saturated during next high water event and could be a sign of internal pipe degradation. LS outlet and slope looked good. Urgent due to long crack, obstructed inspection view of WS inlet, and 2016 photos of holes in pipe (D. Sanoski - DWR UCIP).6/15/2017 WS pipe end still showing heavy signs of corrosion and deterioration with visible holes between the concrete headwall and flap gate flange. Pipe was almost 100% full of water so could not visually inspect inside of the pipe to see if theres any damage inside of the levee segment. Pipe has been selected to be internally cleaned and inspected as part of the DMP project. (DWR Sutter Yard - AFreitag)11/17/2016 Top of pipe on WS still showing heavy signs of corrosion with visible holes between the flapgate flange and the concrete headwall. The pipe was mostly underwater so could not internally inspect it for more damage or corrosion. (DWR Sutter Yard - AFreitag)5/03/2016 Top of the pipe on the WS has holes in it between the flapgate flange and headwall. Crossing is showing signs of rust and deterioration but it was mostly underwater so could not inspect the inside of the pipe. (DWR Sutter Yard - afreitag)7/13/2015 Both sides of crossing were underwater at the time of inspection. (DWR Sutter Yard - afreitag)5/22/2014 Same as last inspection. (DWR Sutter Yard - afreitag)12/3/2013 Same as last inspection. (DWR Sutter Yard - afreitag)7/15/2013 Slopes have been cleared of vegetation and are in good condition. WS flapgate is still lodged open. (DWR Sutter Yard - afreitag)4/18/2012 Limited inspection on LS slope due to dense vegetation. Need photos of cleared WS & LS slopes. The flap gate is lodged open. (DWR UCIP - omagana)

Headwall and flapgate located on water side of levee

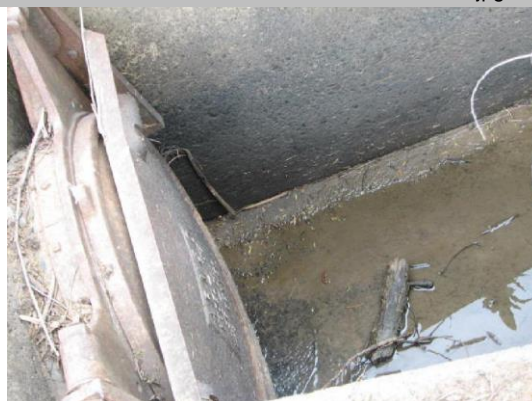
Photo 1 of 3 : UCIP_FA_2018_52242_66981.jpg

Comment Code					
Inspector Comment					
FS_ID:52242 DS_ID:16367 EP_NO: N/A Repair Type: No Action Needed Crossing Status: Found UCIP Comments: 6/15/2017 Crossing appears to be in good condition. Pipe has been selected to be internally cleaned and inspected as part of the DMP project. (DWR Sutter Yard- AFreitag)11/17/2016 Crossing appears to be in good condition. (DWR Sutter Yard- AFreitag)5/03/2016 Crossing appears to be in good condition.7/13/2015 Crossing appears in good condition. No noticeable issues to report.5/22/2014 Same as last inspection.12/3/2013 Same as last inspection.7/15/2013 Slopes have been cleared of vegetation and are in good condition.4/18/2012 Limited inspection on WS and LS slope due to dense vegetation. Need overall photo of crossing and photos of cleared WS & LS slopes. FIELD_STRUCT_DESC: 36-inch corrugated metal drainage pipe through the levee, 12.4 feet below the crown. Concrete "U" headwalls on both waterside (WS) and landside (LS). Flap gate on the waterside (WS) end. [Additional Reference(s): DWR Levee Log, 1993. USACE Sacramento O&M Manual 519, June 1962 (HLM 15.12)] FS Date: 6/19/2017 2:01:26 PM

WS headwall and flapgate

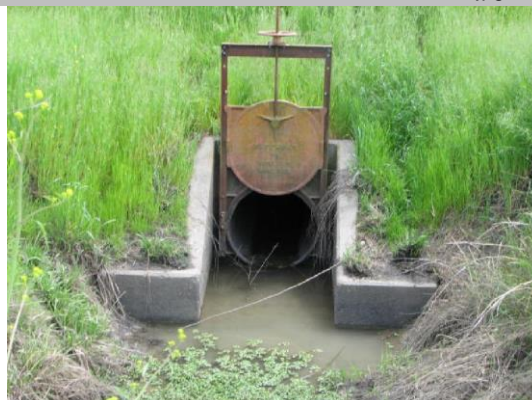
Photo 2 of 3 : UCIP_FA_2018_52242_66980.jpg

Slide gate located on LS toe. Dense vegetation present on LS slope.

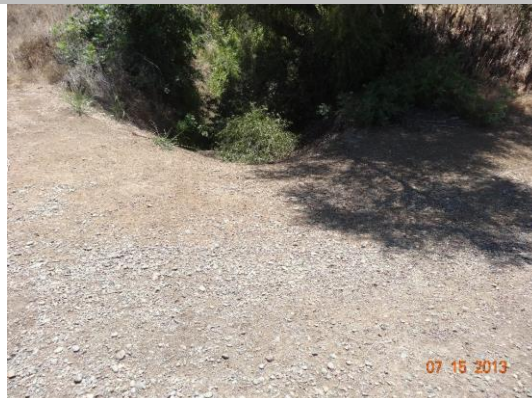
Photo 3 of 3 : UCIP_FA_2018_52242_66982.jpg

WS slope cleared of vegetation
